the MANAGER

WINTER 2004

School & Municipal Roofs

Inspect Them Now or Investigate Them Later

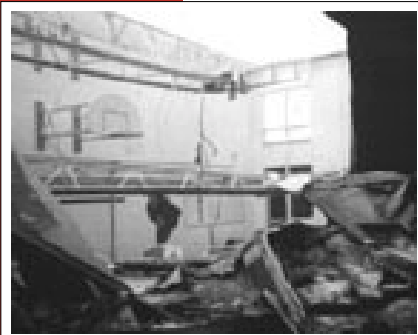
Roof fails from wet snow overload at Claypit Elementary School in Wayland, MA, 2003.

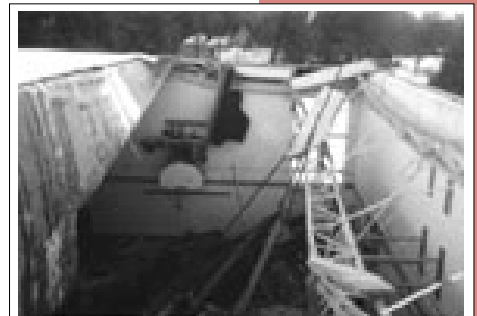
Faulty construction can negate architectural safe load calculations for water or snow accumulation, especially if there is roof-sag.

*Courtesy Wayland, MA School Dept.
Claypit Elementary School, 2003.*
